INTEGRITY FIRST AZ

Home Inspection Report

123 Main Street, Phoenix, AZ 85001

Thursday October 1, 2020

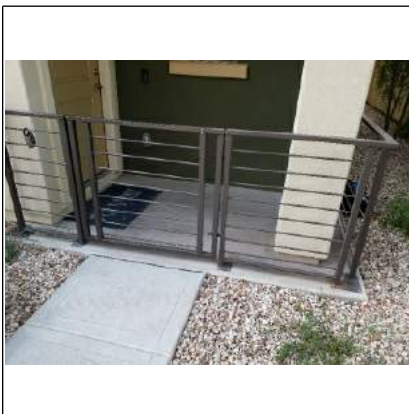
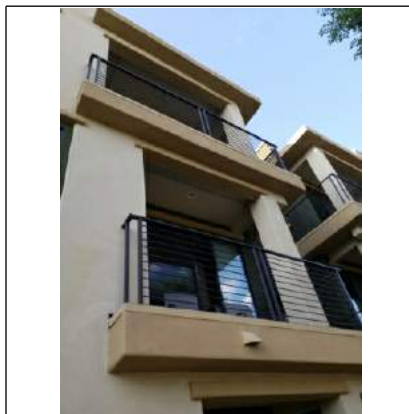
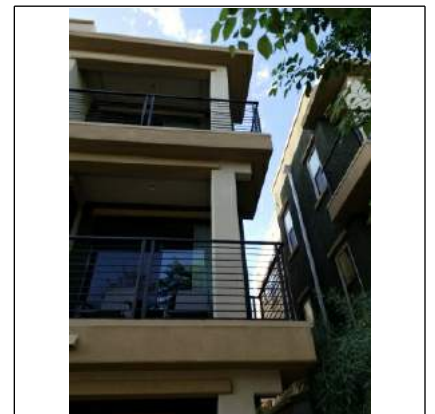
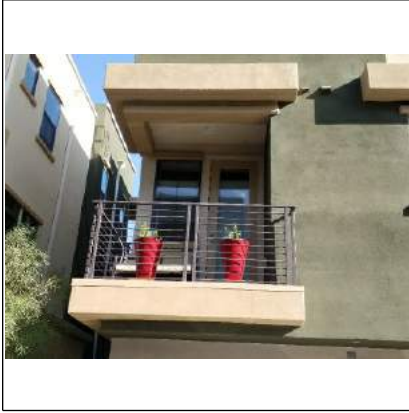
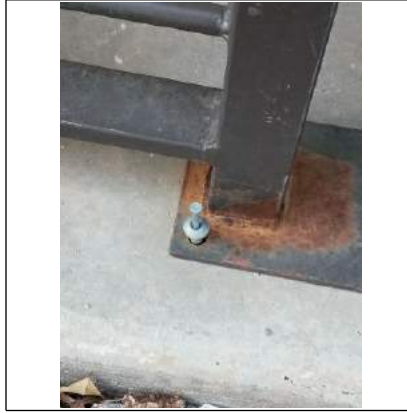
Comments - During inspection, observed horizontal balusters on all PORCH guardrails. In this orientation, balusters can potentially be utilized by small children as ladder rungs. Recommend licensed contractor evaluate and provide remedy options as required.
Safety Hazard.

-Observed protruding rivet and rusting on FRONT Porch guardrail post. Recommend licensed contractor evaluate and remedy as needed.

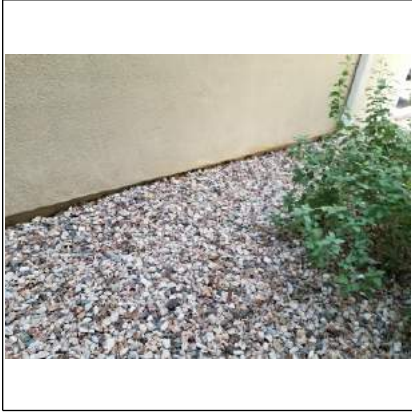
Comments - Observed grading too close to the bottom of the residence's stucco siding in several locations. Recommend a clearance of 6" - 8" from bottom of siding to grade be maintained in order to prevent possible water intrusion and/or damage.

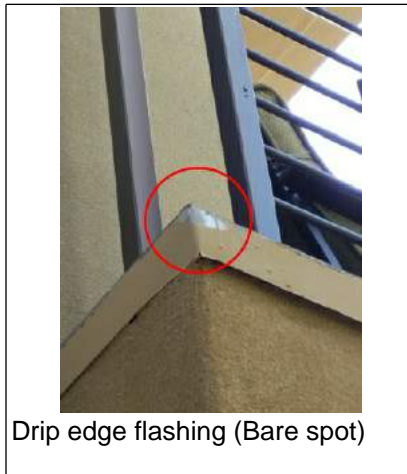
Comments - During inspection, observed bare spots on drip edge flashing around perimeter of PORCH cover. Recommend painting / sealing flashing where needed and / or consulting with a licensed and qualified roofer to evaluate and offer possible remedy options.

Drip edge flashing (Bare spot)

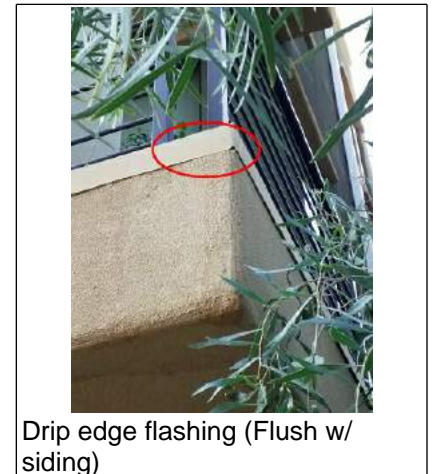
- Observed drip edge flashing along PORCH cover flush with stucco-finished outer fascia boards and not overlapping (see photo below), which results in draining rainwater remaining in contact with stucco far longer than if lip of flashing extended over stucco finish. Left untreated, moisture intrusion into stucco and onto outer porch fascia can potentially occur. Recommend licensed contractor evaluate and offer possible remedies.

Drip edge flashing (Flush w/ siding)

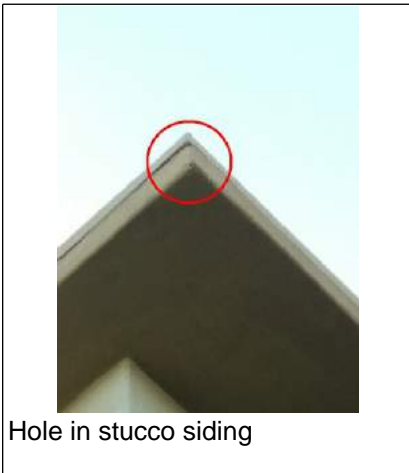
Comments - Holes and gaps observed in wall siding during inspection (see photos below) .
Openings such as these potentially allow for water and/or pest intrusion. Recommend licensed contractor evaluate all gaps in siding coverage and propose remedy options.

Hole in stucco siding

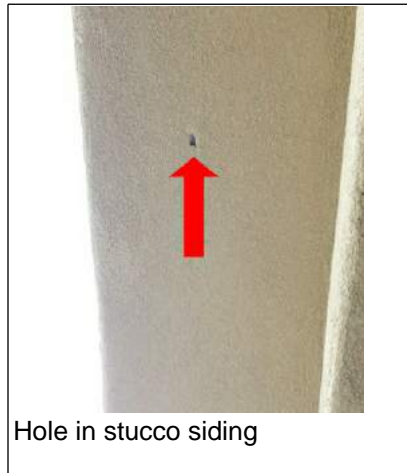
Hole in stucco siding

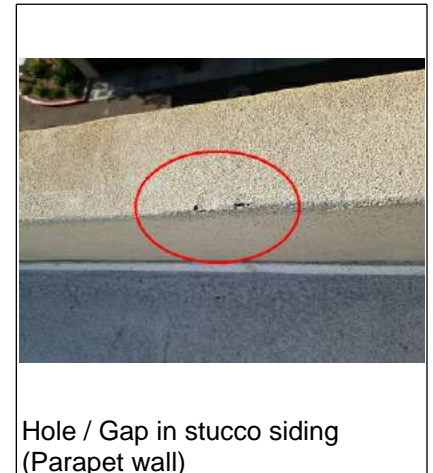
Hole / Gap in stucco siding
(Parapet wall)

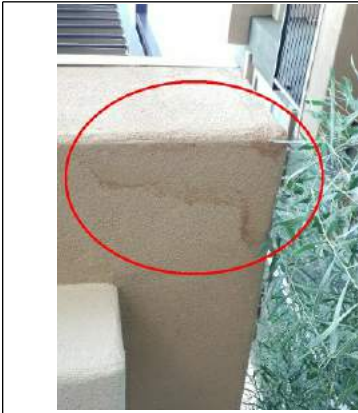
- During inspection, observed areas of moisture-damaged siding. Specifically, siding exhibited signs of past / present water intrusion. Recommend consulting with a licensed and qualified contractor to evaluate and provide remedy options as needed.

Moisture damage

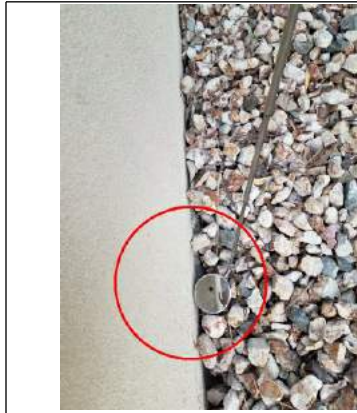
Weep screed hole

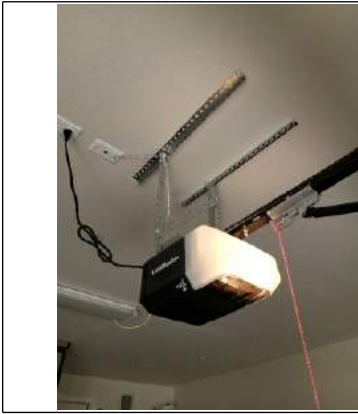
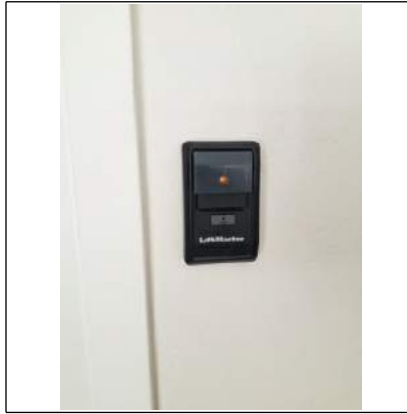
- During inspection, GARAGE overhead door failed balance testing, which is a test of the overall balance of the garage door during manual operation. Door did not stay in place when hand was removed while door was raised halfway. Recommend adjustment by licensed contractor. **Safety Hazard**.

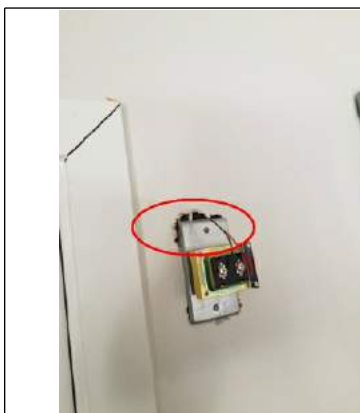
Comments - During inspection, observed hole in wall of garage (see photo below). Holes in fire separation walls or ceilings negatively impacts the ability of the fire separation system (walls, ceilings and doors) to adequately prevent a fire from entering the residence. Recommend a licensed contractor evaluate and affect needed repair(s). **Safety Hazard**.

Hole in GARAGE wall

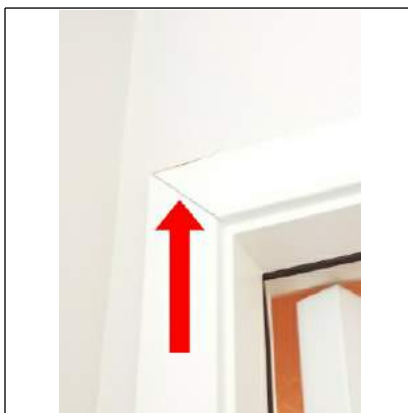
- Observed trim around GARAGE door separated in several locations. Recommend licensed contractor evaluate and offer remedy options.

Separation in trim around GARAGE door

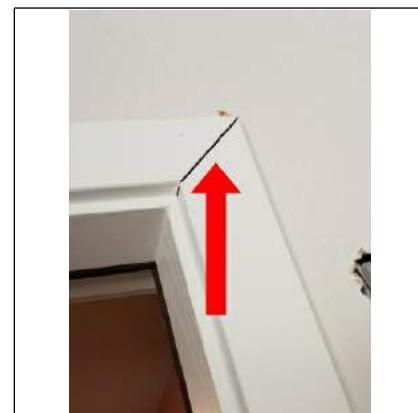
Separation in trim around GARAGE door

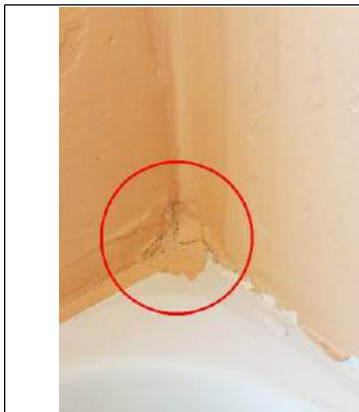
Comments - Observed cracking and holes along walls of 3rd Floor, RIGHT REAR Bathroom during inspection. Recommend sealing and monitoring areas for any ensuing cracking, widening and/or displacement, which may indicate more serious issues.

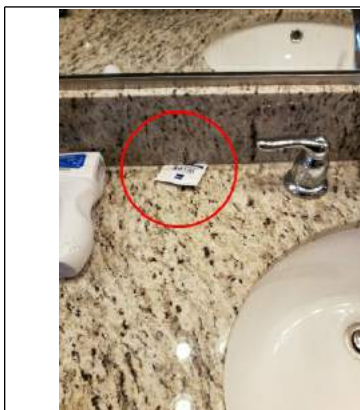
Comments - During inspection, observed gaps in grout coverage at intersection of countertop surface & backsplash in 3rd Floor, RIGHT FRONT Bathroom. Missing grout can potentially lead to water intrusion. Recommend application of grout in area(s) noted above.

3rd Floor, RIGHT FRONT Bathroom (Missing grout)

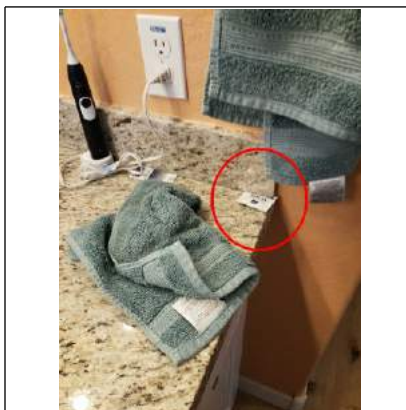
3rd Floor, RIGHT FRONT Bathroom (Missing grout)

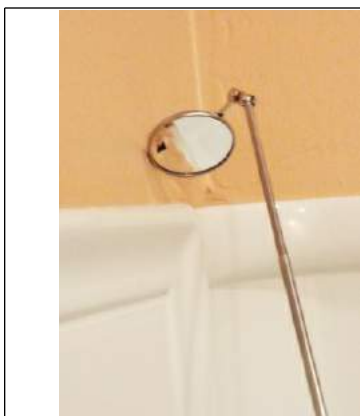
Comments - Minor cracks and gaps in caulking / grout coverage observed in several BATHROOM locations (see photos below). Recommend evaluate and application of caulking / grout as needed.

1st Floor, RIGHT FRONT Bathroom (Gap in caulking coverage)

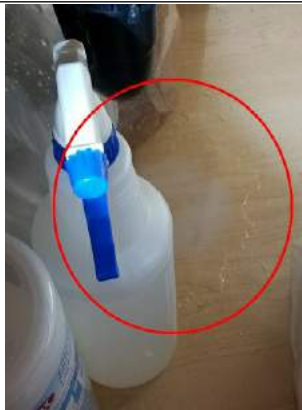
- Observed active leak from bathroom sink drain pipe in 1st Floor, RIGHT FRONT Bathroom during inspection. Recommend licensed plumber evaluate and repair as required.

1st Floor, RIGHT FRONT Bathroom (Active leak)

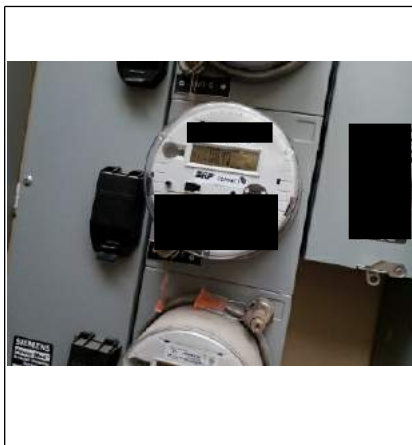
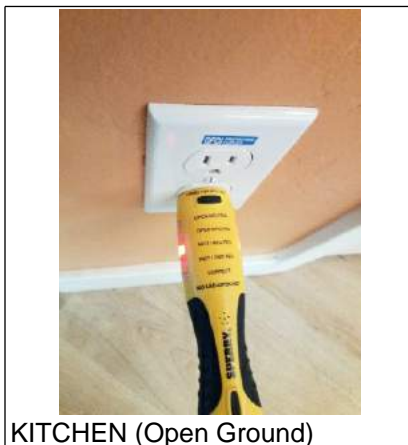
Comments -During inspection of receptacles, observed three-pronged electrical receptacles in a "Reverse Polarity" state (see photos below). This is an unsafe condition as the receptacle's neutral wire is connected to where the hot (live) wire is supposed to be, and vice versa. Potential exists for shock and/or damage to equipment. Recommend evaluation and repair of all receptacles by a licensed and qualified electrician. **Safety Hazard**.

KITCHEN (Open Ground)

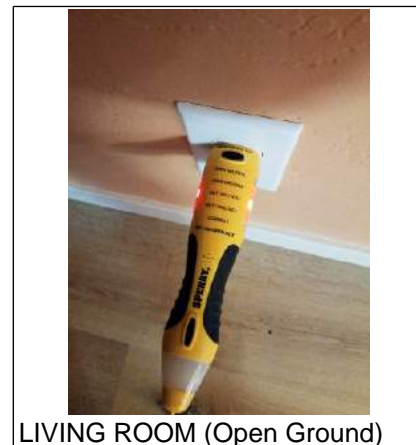
LIVING ROOM (Open Ground)

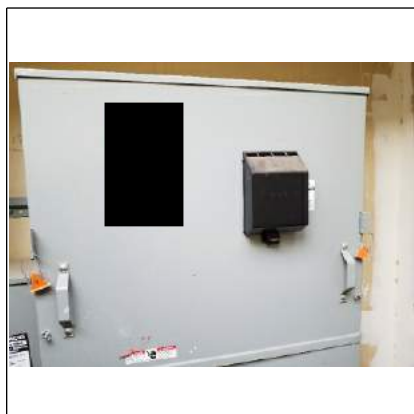
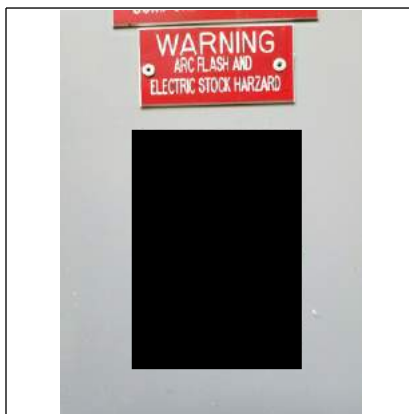
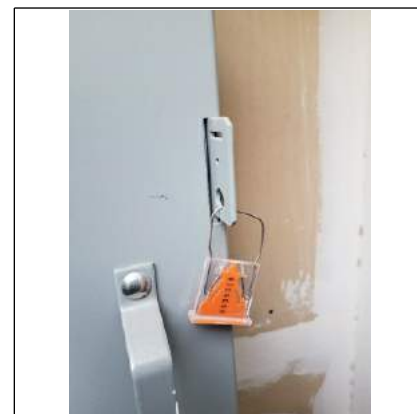
Comments - Shared main electrical panel. Unable to access "dead front" cover of main panel during inspection due to locked panel door (see photos below). Recommend licensed electrician remove cover and evaluate breakers and wiring for condition and compatibility.

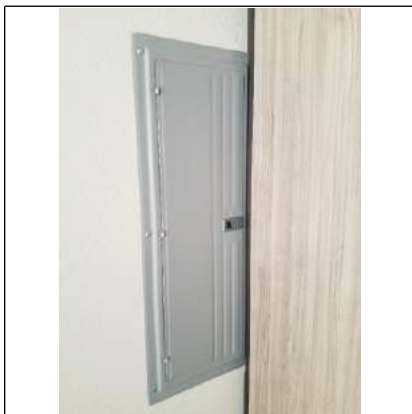
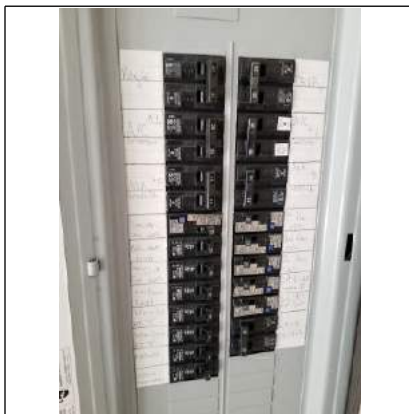
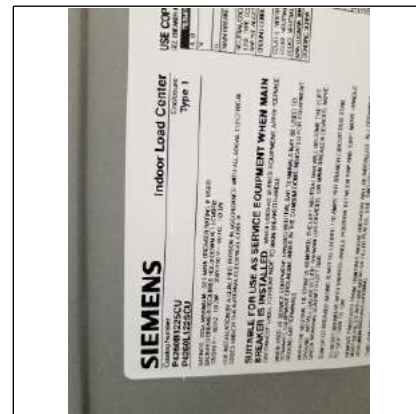
Comments - Unable to remove dead front cover of distribution panel during inspection without causing damage to surrounding painted areas and cabinetry. Mandated working distances on all sides of panel have not been adhered to--recommend licensed electrician evaluate distribution panel, overcurrent devices and branch wiring compatibility as soon as practical.

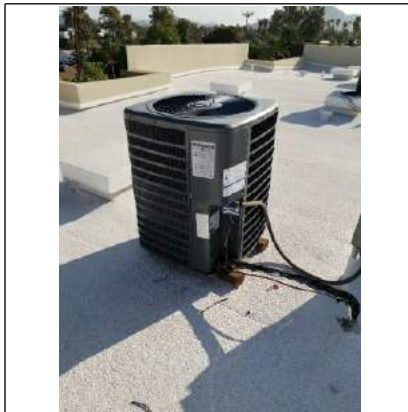
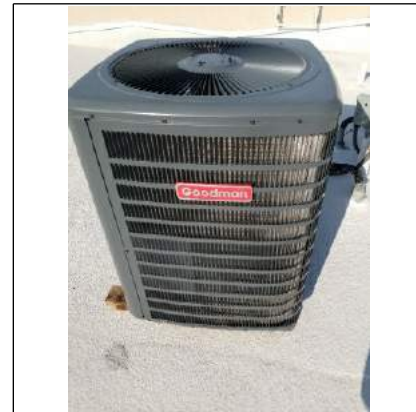
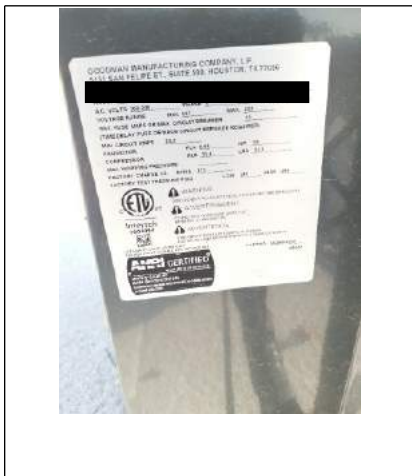
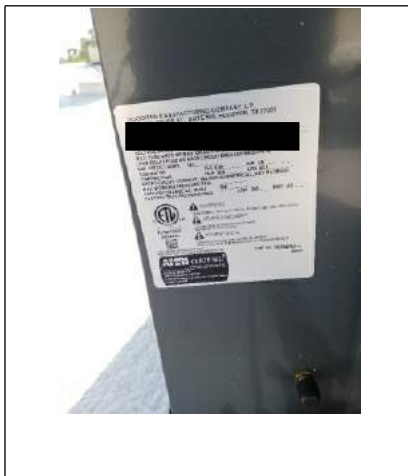
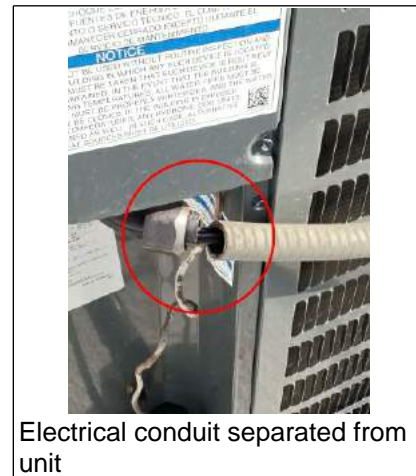
- Gap observed between electrical conduit and heat pump unit during inspection. Any openings or gaps in electrical conduits allow for potential shock hazard and/or water intrusion. Recommend licensed and qualified electrician evaluate and repair as required. **Safety Hazard**.

Electrical conduit separated from unit
