INTEGRITY FIRST AZ

Home Inspection Report

123 Main Street, Phoenix, AZ 85001

Thursday October 1, 2020

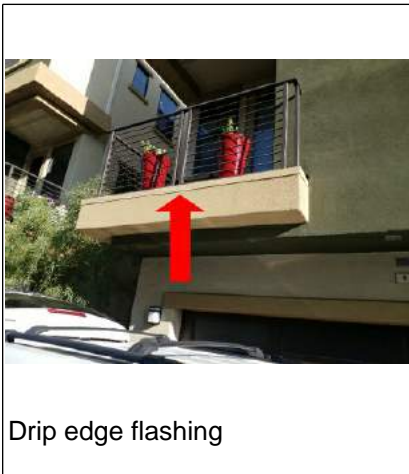
- Observed drip edge flashing along PORCH cover flush with stucco-finished outer fascia boards and not overlapping (see photo below), which results in draining rainwater remaining in contact with stucco far longer than if lip of flashing extended over stucco finish. Left untreated, moisture intrusion into stucco and onto outer porch fascia can potentially occur. Recommend licensed contractor evaluate and offer possible remedies.

Drip edge flashing

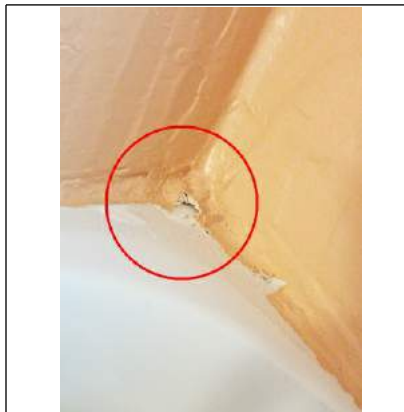
- Observed cracking and holes along walls of 3rd Floor, RIGHT REAR Bathroom during inspection.
- During inspection, observed gaps in grout coverage at intersection of countertop surface & backsplash in 3rd Floor, RIGHT FRONT Bathroom.
- Minor cracks and gaps in caulking / grout coverage observed in several BATHROOM locations.
- Observed active leak from bathroom sink drain pipe in 1st Floor, RIGHT FRONT Bathroom during inspection.

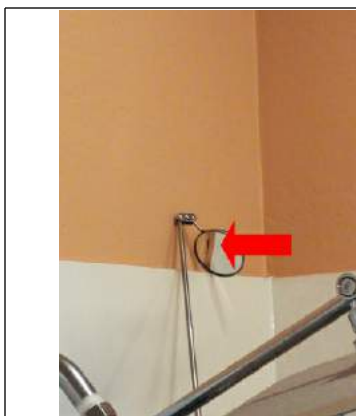
3rd Floor, RIGHT FRONT Bathroom (Gap in caulking coverage)

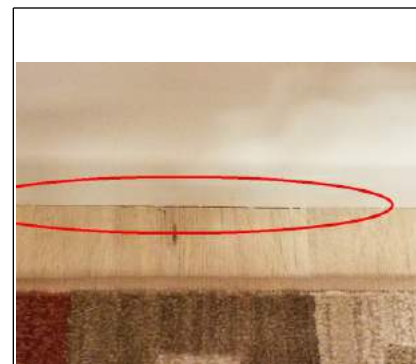
3rd Floor, RIGHT REAR Bathroom (Gap in caulking / grout)

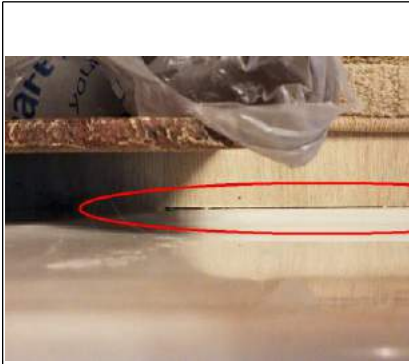
3rd Floor, RIGHT REAR Bathroom (Gap in caulking / grout)

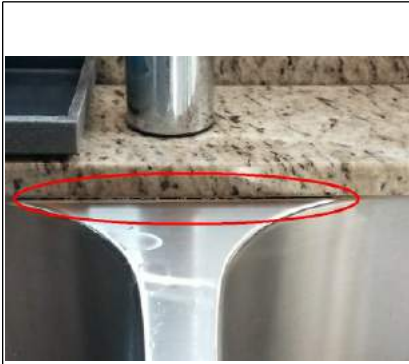
- During inspection, observed gaps in caulking coverage at intersection of countertop surface & KITCHEN sink.

Gap in caulking coverage

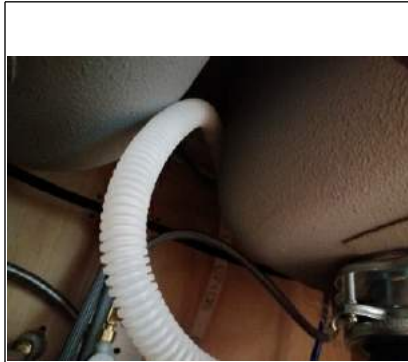
- Dishwasher drain line not properly high-looped to underside of countertop. Cross connection is possible in this situation, which could result in dirty water from the dishwasher and/or garbage disposal being re-introduced and contaminating clean dishes.
- During inspection, observed RANGE with no anti-tip bracket installed (or installed improperly allowing range to tip over). Anti-tip brackets have been required by all appliance manufacturers since 1991.

Dishwasher drain line (Not properly high-looped)

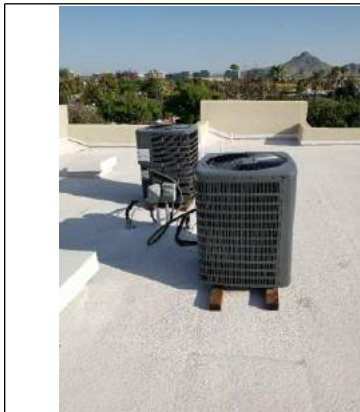
- Gap observed between electrical conduit and heat pump unit during inspection. Any openings or gaps in electrical conduits allow for potential shock hazard and/or water intrusion.

Electrical conduit separated from unit
